Manhole Inspection Summary

Manhole # S29OO1027MH

Insp Date: **7/3/07 9:37 AM**

Location Address: **219 ALPINE RD**

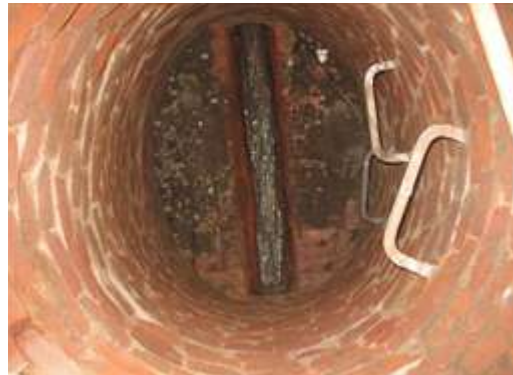
Top View

Bench ☒ Exists Material: **Brick** ☐ Parged ☒ **Debris** (not Condition related)

Surcharge ☒ **Evidence Of Surcharge** Depth: **1** (ft.) ☐ Active Surcharge Present

Evidence of surcharge - Bench debris.

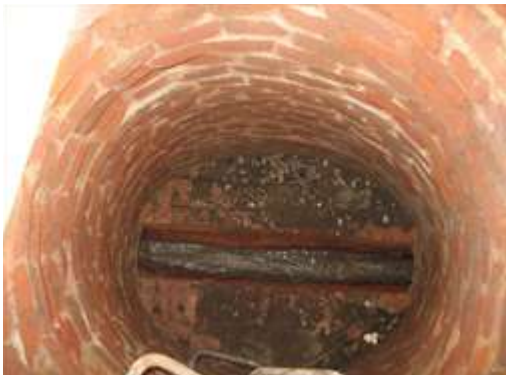
Defect

Infiltration: ☐ None ☒ **Joint** ☐ Cracks ☐ Mortar ☐ Roots ☒ **Wall**

Infiltration: ☐ None ☐ Joint ☐ Cracks ☒ **Mortar** ☐ Roots ☒ **Wall**

Adjustment and Barrel infiltration.

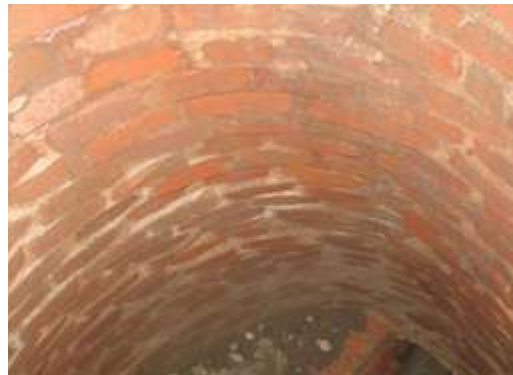
Defect

Adjustment and Barrel infiltration.

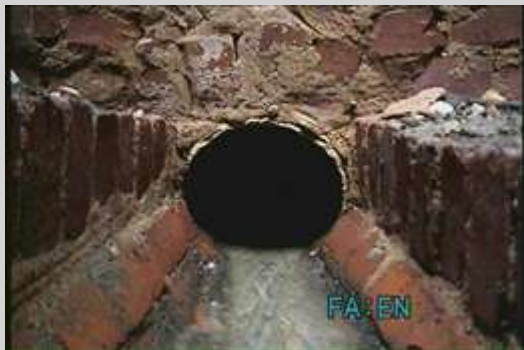
8 in. Circular Gravity Sewer Pipe Out @ 12 O'Clock

Infiltration: **None** Pipe Seal Cond: **Cracked**
